**Treatability Study Phase 2
Technical Memorandum
Cooling Water Canal
(SWMU No.5)
Peñuelas, Puerto Rico**

**Peñuelas Technology Park LLC
Peñuelas, Puerto Rico**

August 2012

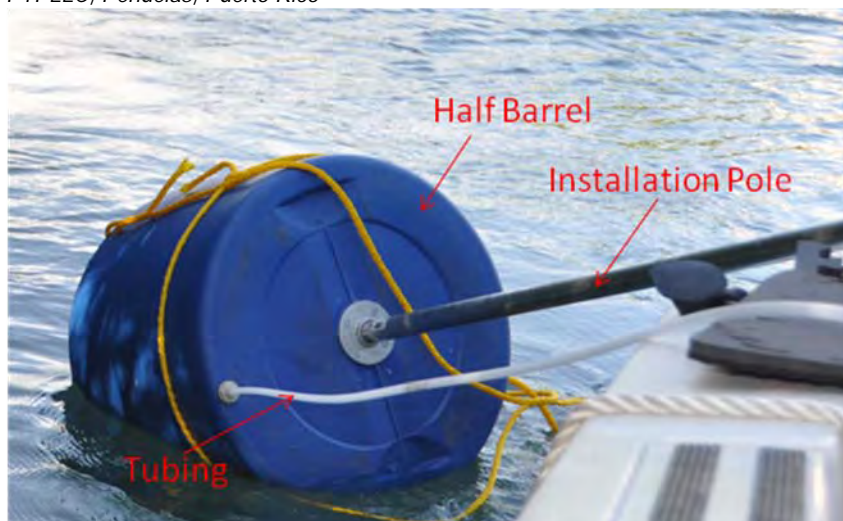
Figure 3-1
Seepage Meter Assembly
PTPLLC, Peñuelas, Puerto Rico

During Phase 2 field work, only one seepage meter (HB2) was successful in obtaining readings for a longer duration than was obtained in Phase 1, and showed that the weight of the water collection bag increased and then decreased. The results are presented in **Table 3-1**. The results for HB2 indicated upward flux of 0.001 centimeters per day (cm/d) in the first 72 hours, followed by - 0.0139 cm/d in the following 48 hours. This positive upward flux followed by negative downward flux can be attributed to the tidal action. The other two attempts were abandoned mid-study because one seepage meter was pushed up by the barge and insufficient time was left to reinstall the meter (HB3); the other meter was found floating (HB4), assumed to be the result of natural buoyancy.

to reinstall the meter, and because the other meter was found floating (assumed to be the result of natural buoyancy).

Based on this study, it was noted that half-barrel seepage meters should be constructed out of metal drums, installed in shallow water with good visibility, and preferably inspected by a diver to make sure the meters are installed correctly. An alternative to divers is a viewing tube made from 6- inch PVC pipe, Plexiglas, and silicone caulk.

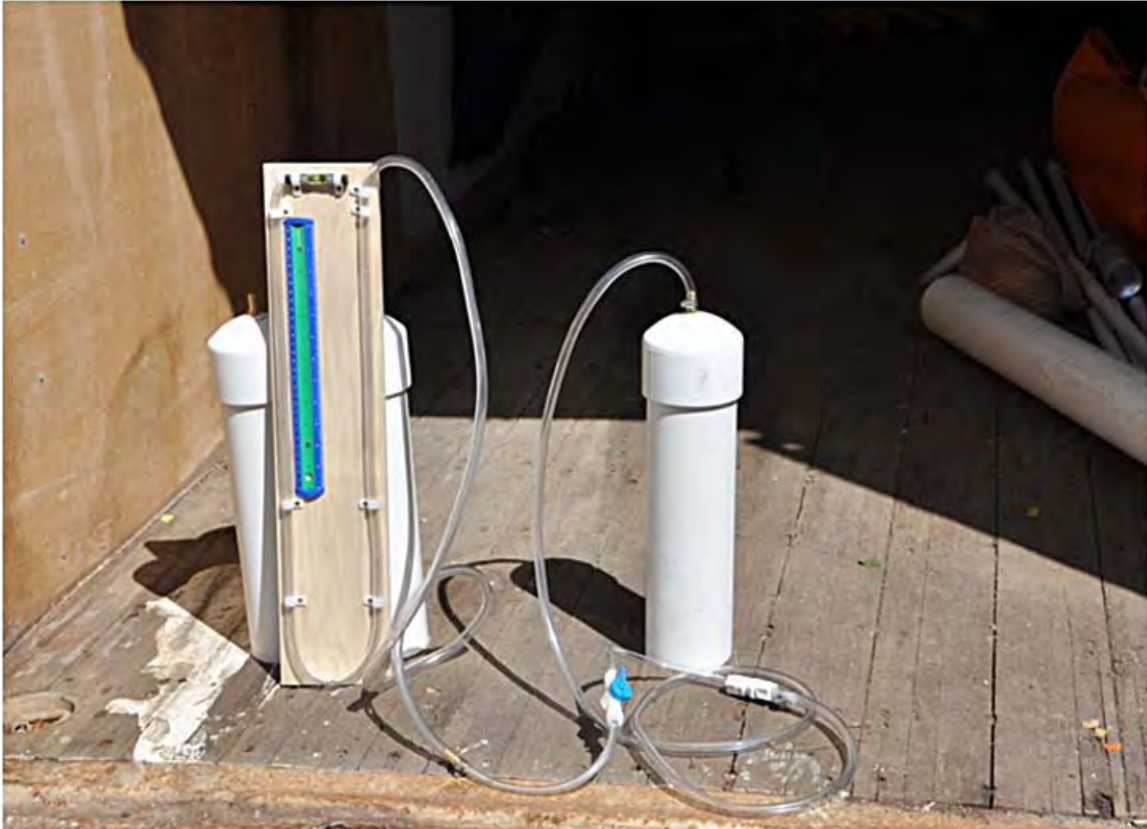
FIGURE 3-3
Gas Ebullition Test Kit
PTPLLC, Peñuelas, Puerto Rico

After installation of the gas ebullition test assembly (see location in Figure 3-2), the tubing valve was closed and the meter was checked after 24 hours. The tubing coupling was connected to the U-tube manometer and the valve was opened to check the pressure. Opening of the valve allowed the water trapped in the tubing to equalize with the current stage of the tide. This movement of water in the manometer was at least somewhat affected by the canal water level head at the time of the reading. The tidal fluctuation was observed to be the driving force in the tubing as it moved the water column up and down. Therefore, no valid readings could be taken and this test was subsequently abandoned.

Laboratory tests on sediment samples showed no gas generation in Phase 1 studies. The plan was to determine the effect of cap placement that could generate conditions which could potentially be conducive for gas generation; however, no conclusive results could be obtained during laboratory experiments. Therefore, an attempt was made during the Phase 2 pilot studies to assess gas ebullition in the field. A U-tube manometer filled with site water was used to measure the potential gas pressure. Due to high density of site water compared to the gases that could be potentially present in the sediments, however, no valid readings could be obtained. Therefore, no conclusive results could be obtained.

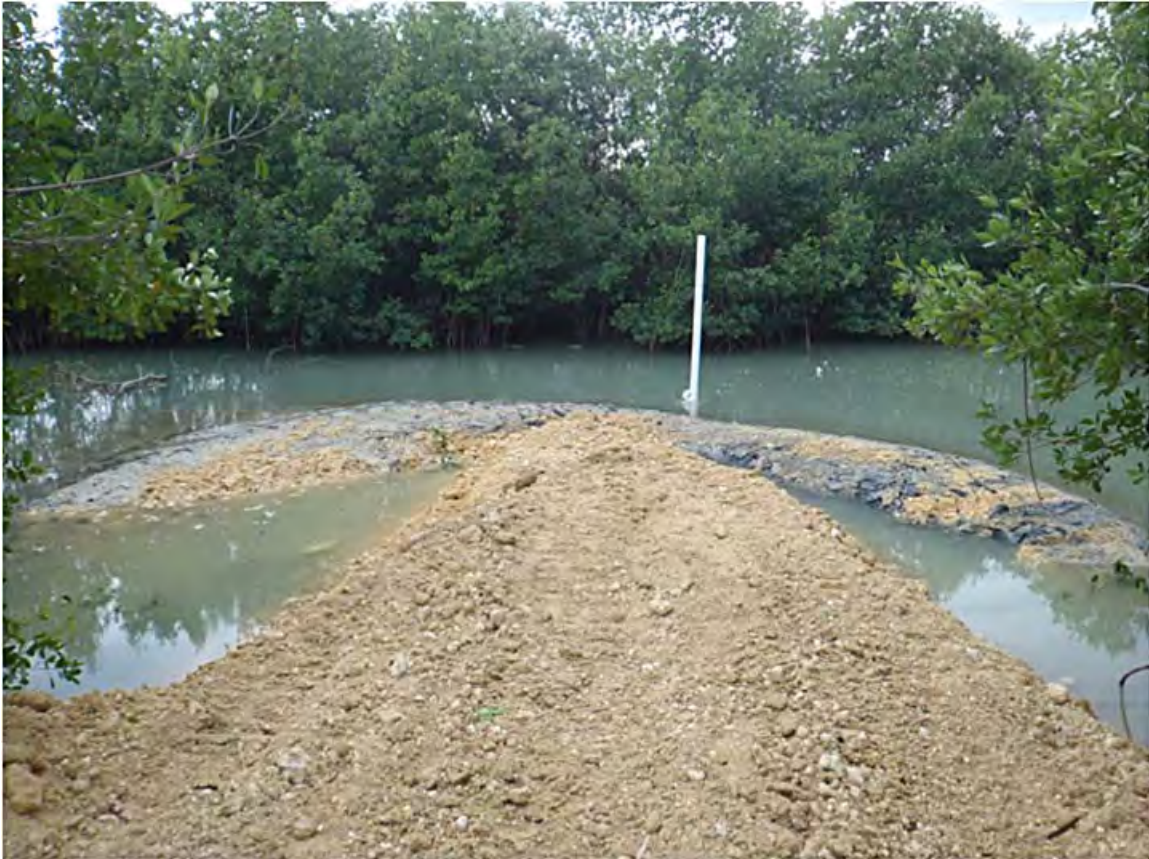
FIGURE 5-2

For Method 2B, loose caliche material was pushed down the previously placed hard pack ramp in 6- to 10-inch lifts over the front edge of the ramp to create a soil mound/stockpile of loose caliche fill approximately 4 to 5 feet high. Each increment of the soil pile was pushed by the bulldozer until enough material had collapsed/cascaded forward, and then additional material was pushed to rebuild the pile and repeat the process. This mound building and ramp extension construction was done without the bulldozer tracking over the loose placement. Little change was observed in the shape or size of the mud wave produced by Method 2A. The final configuration and extent of the ramp and mud waves are presented in Figure 5-1, and a photo of the completed backfill test is shown in **Figure 5-2**.

Photo of Backfill Test

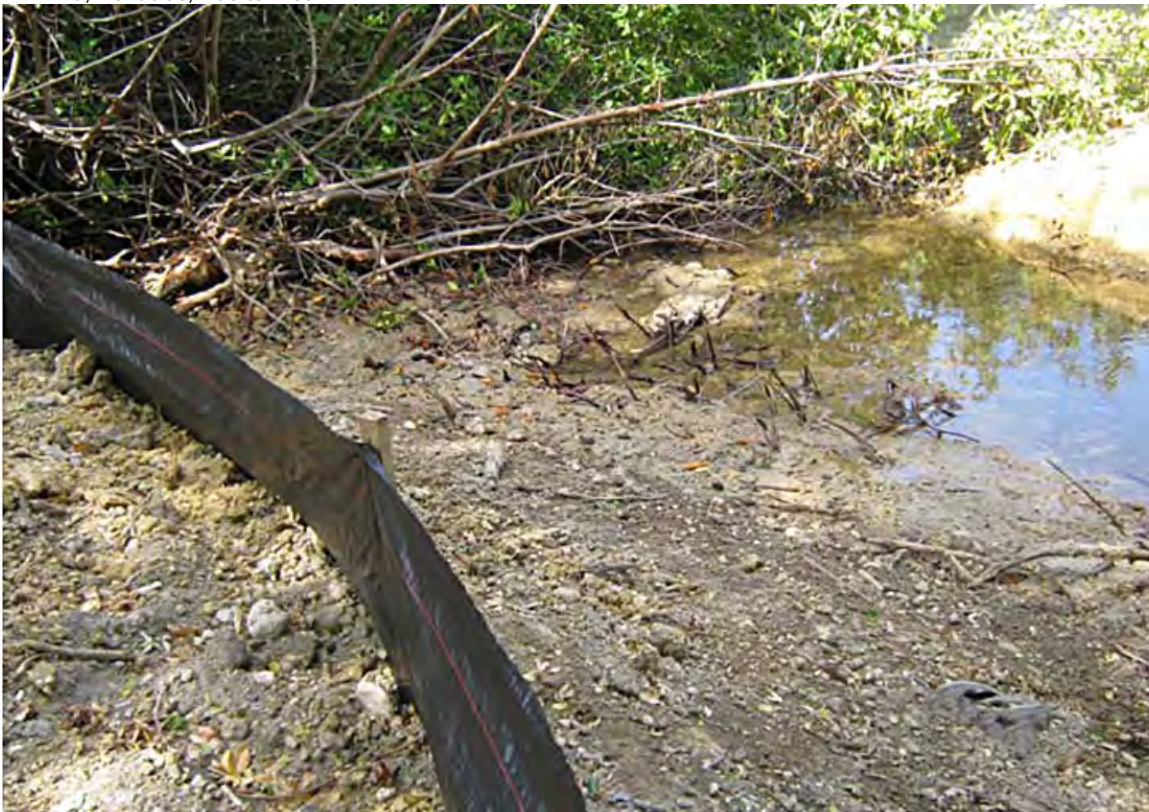
FIGURE 5-3
Restored Conditions after Backfill Test
PTPLLC, Peñuelas, Puerto Rico

Backfill in the canal was left in place to be addressed as part of the final remedy. The fill material placed on the bank within the mangrove zone was removed down to natural ground to allow mangroves to re-vegetate the area. This caliche fill material and the remaining stockpile of caliche were removed to the ILFA for use in other projects. The fence was reattached to the poles and the bank and staging areas were secured and returned to pre-test conditions. Sedimentation and erosion controls (silt fence) were left in place to be removed at a future date when natural erosion controls re-establish. The restored condition on May 31, 2012, is shown in **Figure 5-3**.

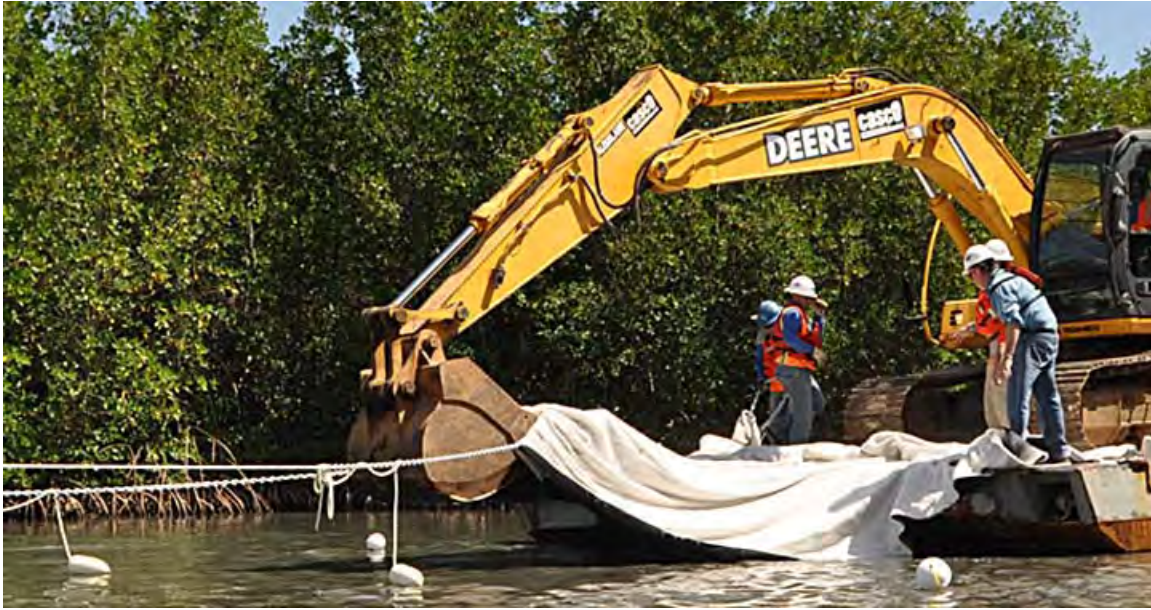
FIGURE 5-5
RCM Installation
PTPLLC, Peñuelas, Puerto Rico

During installation, the RCM pad was intended to be pulled off the barge by two powered watercraft. The on-board excavator was also used, however, because the fabric proved to be too heavy for the watercraft alone. The near end of the mat was held by the barge and slowly lowered until the end reached the bottom. The RCM did not settle into a perfect square and ended up with a narrow plan at the northern end and approximately 22 feet wide at the southern end. Further attempts made to maneuver the RCM into place with the ropes were not successful. High winds also affected the exercise by making it difficult to maneuver the barge. **Figure 5-5** shows the installation of RCM.

During placement of the sand, it was noticed that the corner markers drew in closer to each other; the markers at the southern end eventually were only 9 feet apart. The overall plan of the deployed RCM mat was observed (via markers) to be reduced by approximately 30 to 40 percent after sand placement was completed. The test buckets were also difficult to retrieve from the top of RCM, likely because they sank into the sand cover and underlying soft sediment.

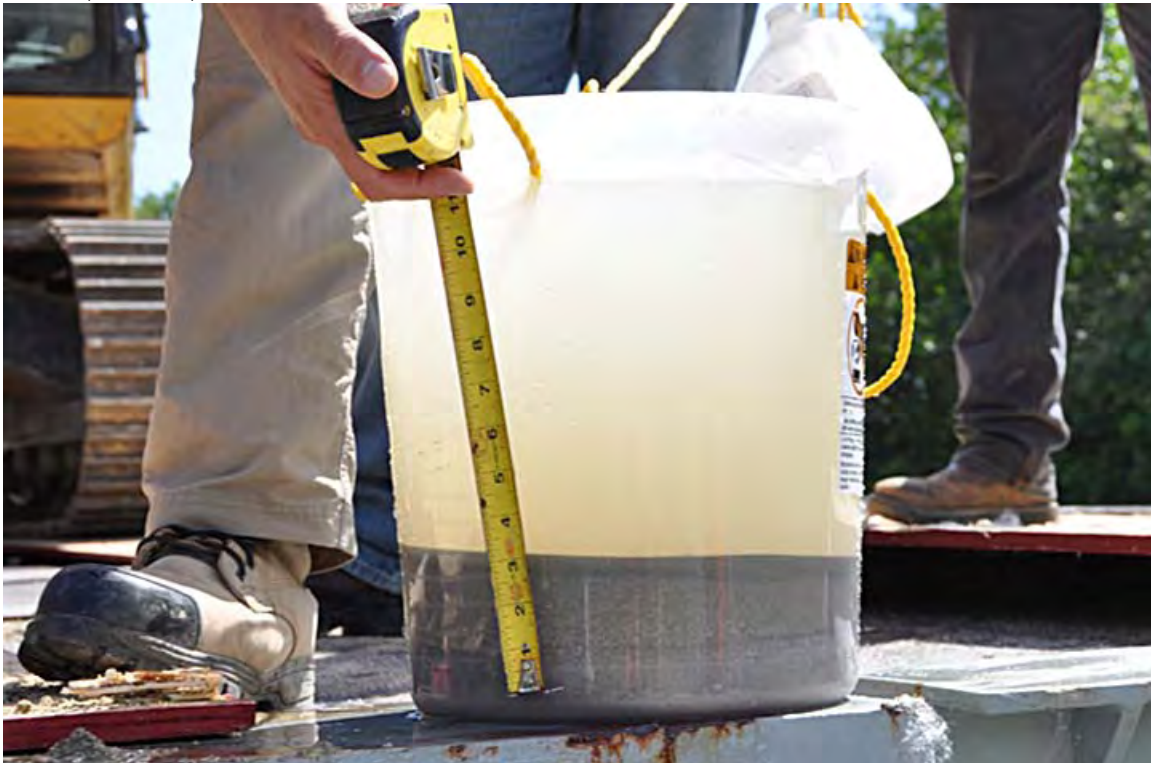
FIGURE 5-6
Test Bucket Showing Sand Layer Thickness for RCM Cap
PTPLLC, Peñuelas, Puerto Rico

Test buckets were placed at intervals as conditions allowed across the RCM prior to the placement of sand. The transparent test buckets were periodically lifted and observed to measure sand layer thickness placed. The measurement data were primarily used to provide feedback to the installation crew rather than to record cap thicknesses.

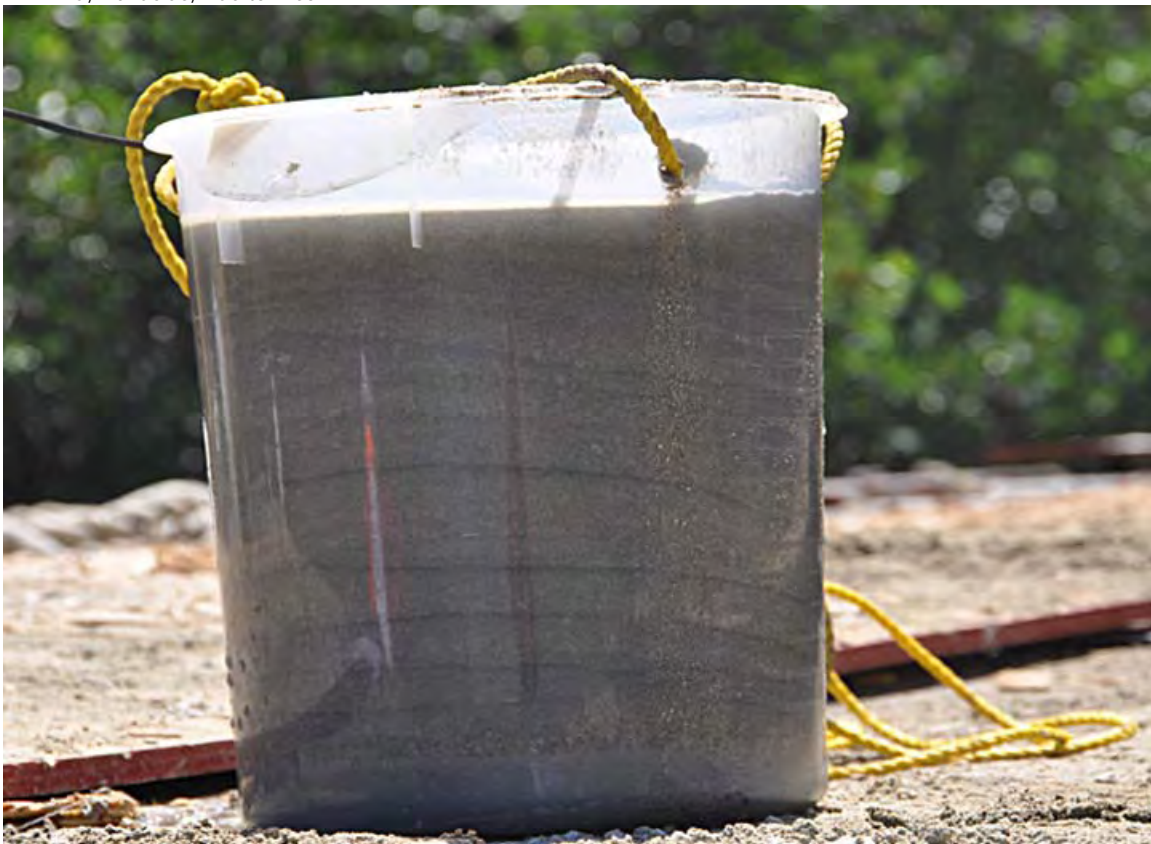
FIGURE 5-10
Sand Cap Test Bucket
PTPLLC, Peñuelas, Puerto Rico

The corner markers and test buckets were installed prior to the installation of the sand cap. Test buckets were placed at intervals as conditions allowed across the cap area prior to the placement of sand. The transparent test buckets were periodically lifted and observed to measure sand layer thickness. The locations of buckets were not recorded and the measurement data were primarily used to provide feedback to the installation crew rather than to record cap thicknesses. Also, the test buckets were only 18 inches deep and not suited to monitor a 24-inch-thick sand layer continuously. Thus, the 24-inch cap placement was estimated. The test buckets could not be placed back onto the area from which they were retrieved because of the tidal current and lack of surface water positioning control (boat and wind drift). **Figure 5-10** shows the test bucket used to monitor the sand cap. The appearance of layers in the bucket indicate that the sand particles segregated by sizes as they passed down through the water column, settling in layers of similar sizes.

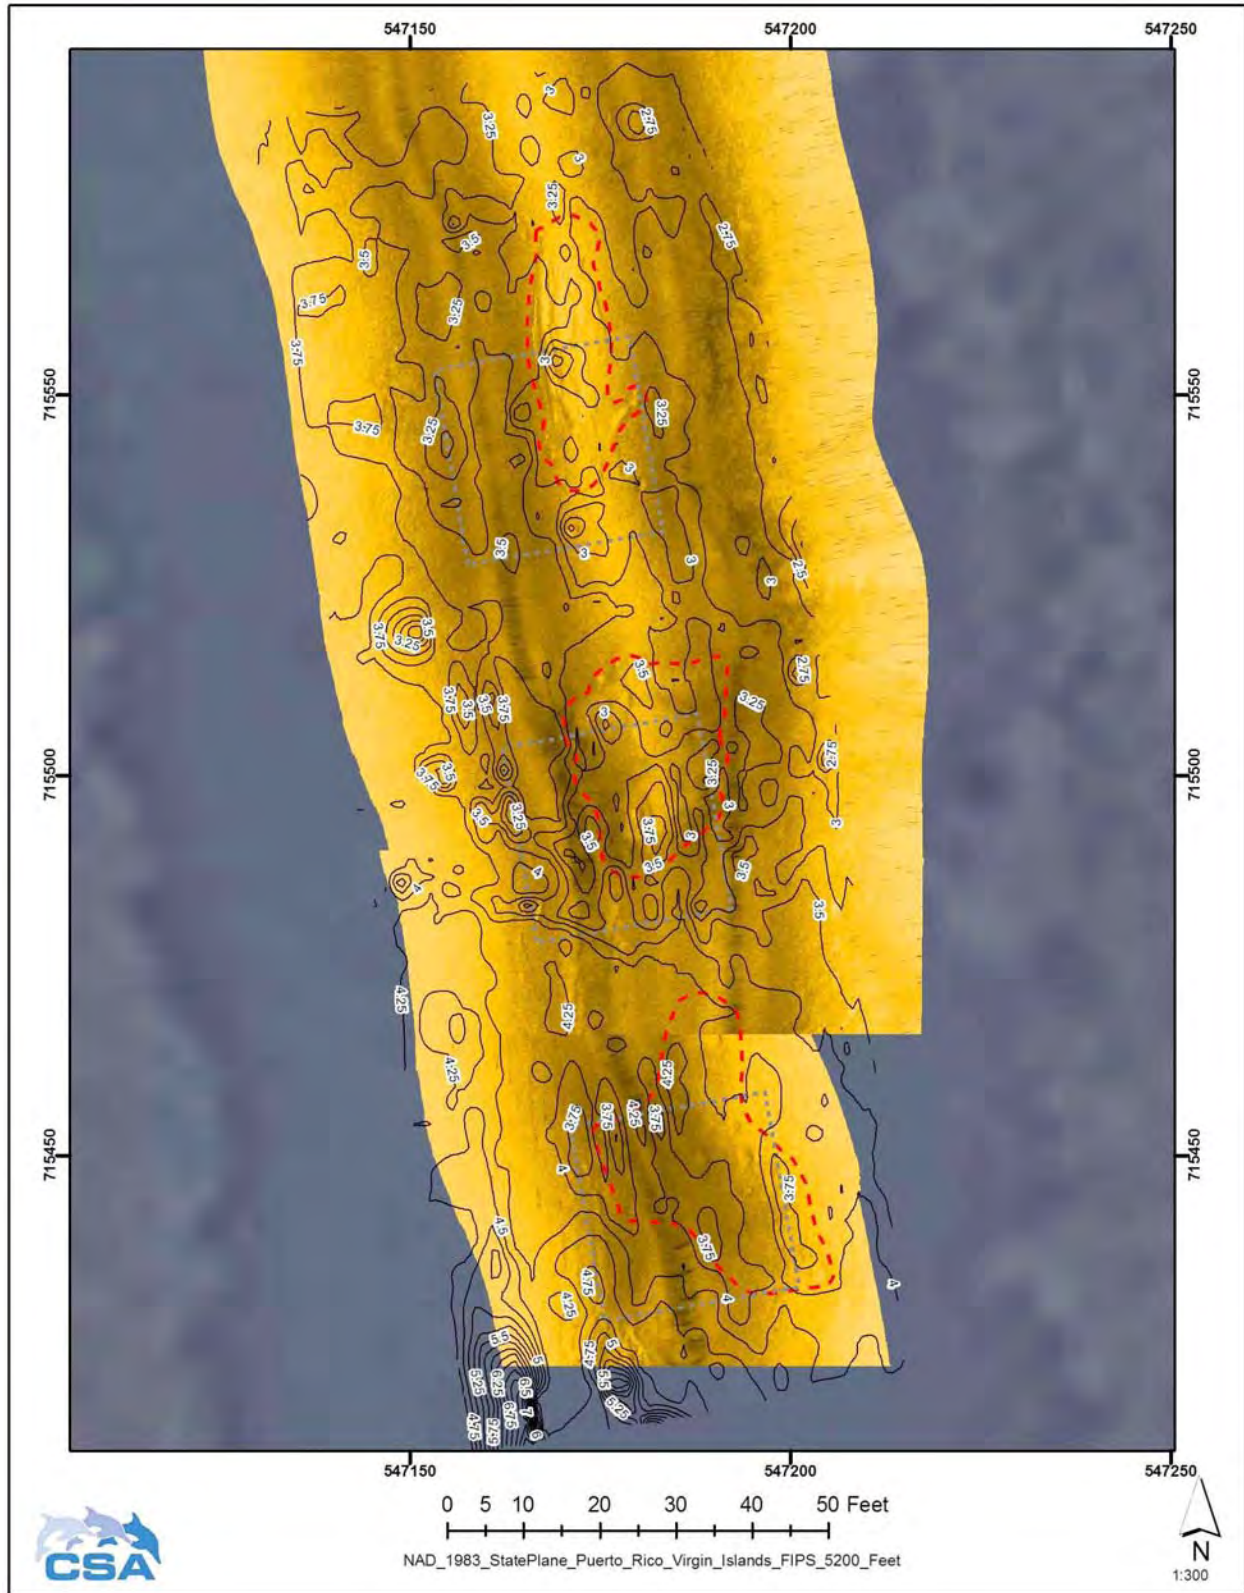
The bathymetric data for all of the cap installations shows minimal elevation above the canal bottom, which is believed to be due to the sand pushing the CETCO-RCM and the AquaBlok materials into the canal bottom sediments and the third cap installation material, sand, settling into the sediments of the canal bottom.

Figure 9. Planned and Post (red dashed lines) cap installation areas in relation to the post side-scan sonar and bathymetric data.
